## Kenwood TS-2000 receiver crackling noise problem

### Ceramic filter failure – how to change the filters

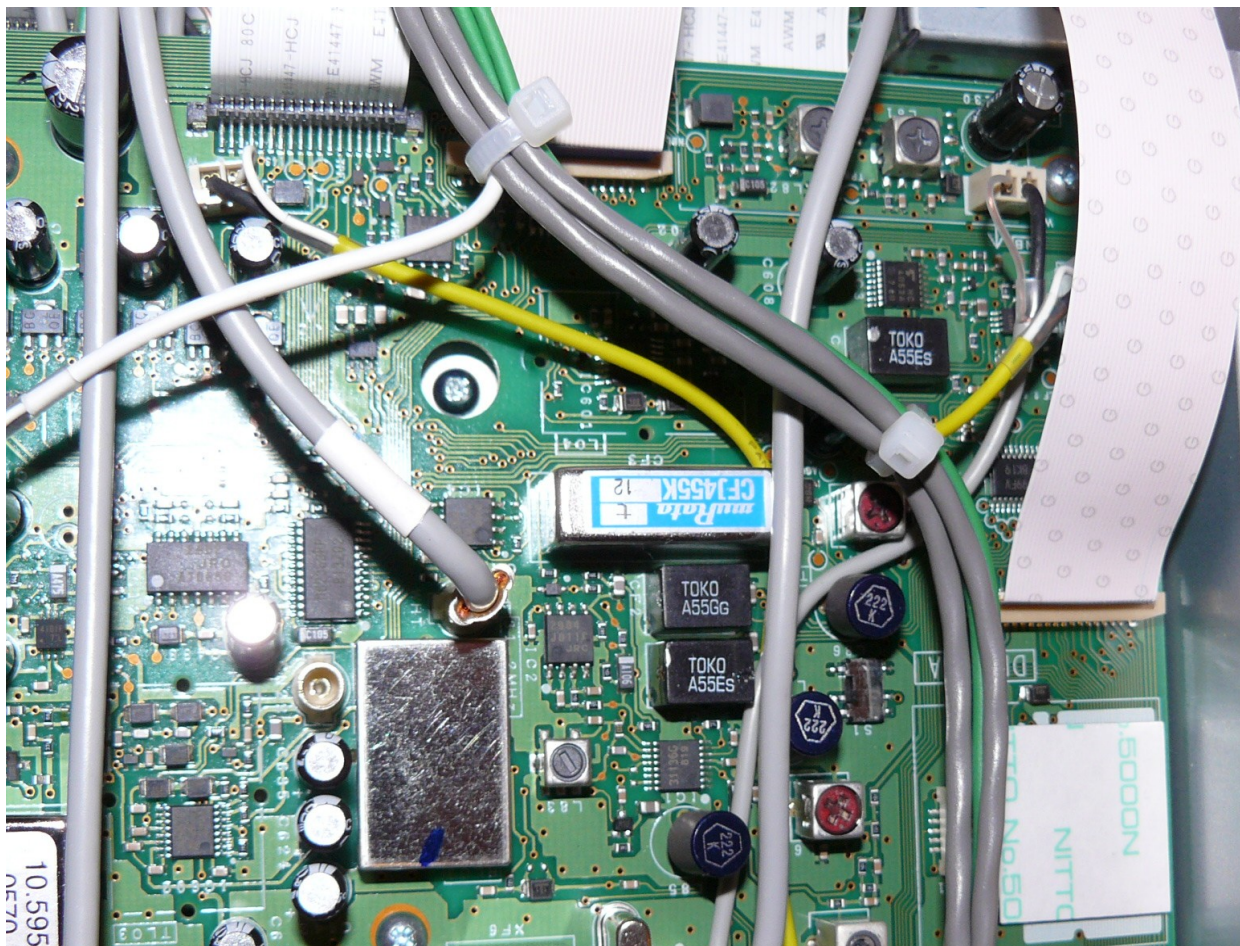
The problem is the failure of the small black ceramic filters (CF1, CF2 and CF4) on the MAIN receiver. But both MAIN and SUB receiver can have this failure. These filters are the TOKO ALFYM455E (15kHz wide) and the ALFYM455G (9kHz wide). I found equivalent filters LTM455EW (15kHz wide) and LTM455GW (9kHz wide). These have exact same electrical data, so it is safe to use them without any re-tuning of the radio. On the SUB receiver, there is 2 ceramic filters on the E (EU) version (FM-W and FM-N), the K (USA) version has only one filter (FM-W).

The MAIN receiver filters are located on the TX/RX board in the bottom (underside) of the radio. The board are marked right next to the filters, CF1, CF2, CF3 (Murata CFJ455K 12) and CF4. The Murata 2.7kHz ceramic filter (CF3) is a different construction and does not need to be replaced.

I decided to replace all filters with YIC LTM455EW and LTM455GW because the original TOKO filters have develop this problem, so I did not want to put in the same filter. These YIC filters is available at eBay for £1.20 (G.B.P) / each. Also, ECS Inc. and others make these LTM455 filters.

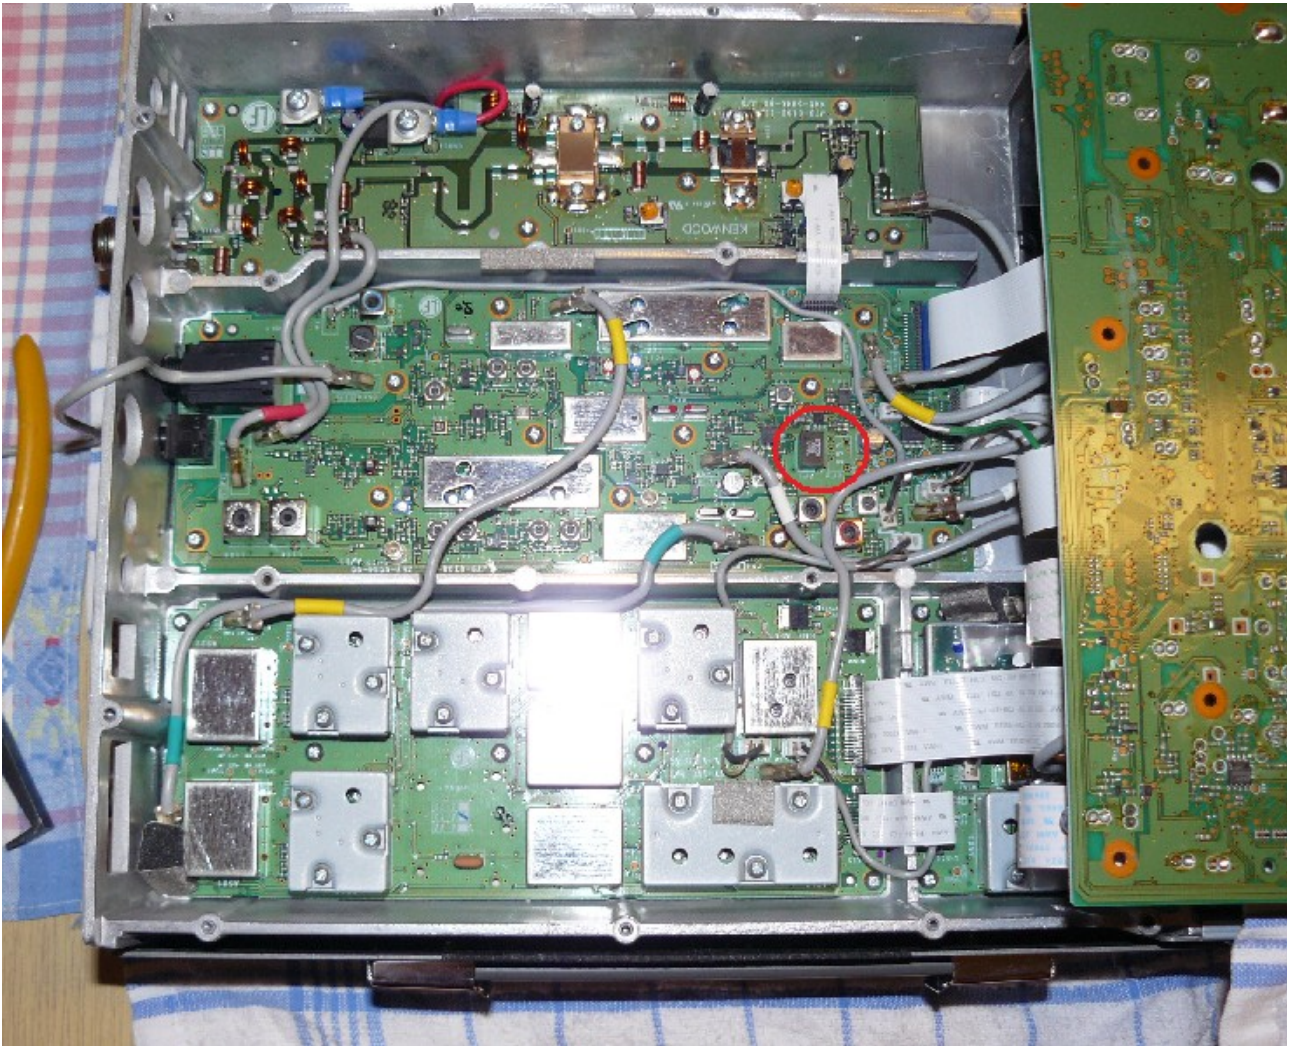
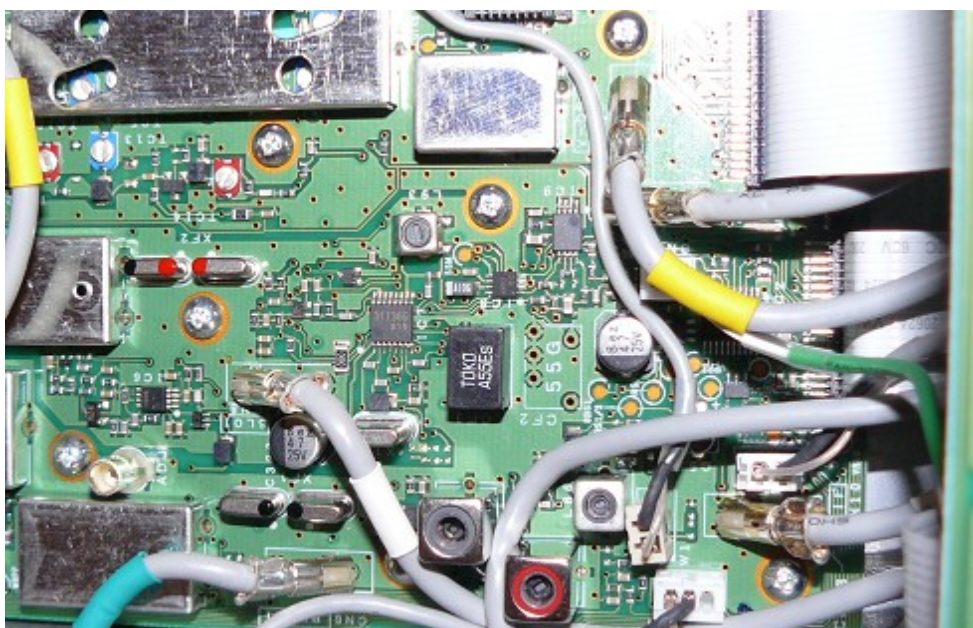
Note this K (USA) version has only the FM-W filter. Replace it with a LTM455EW (15kHz).

You may want to change the SUB receiver ceramic filter(s) as well. Remove the metal shield plate. Locate the Filter on the SUB receiver TX/RX board. This is quite a lot of work as you must remove several cables, then lift out the board and solder out the old filter. Then solder in the new filter(s).

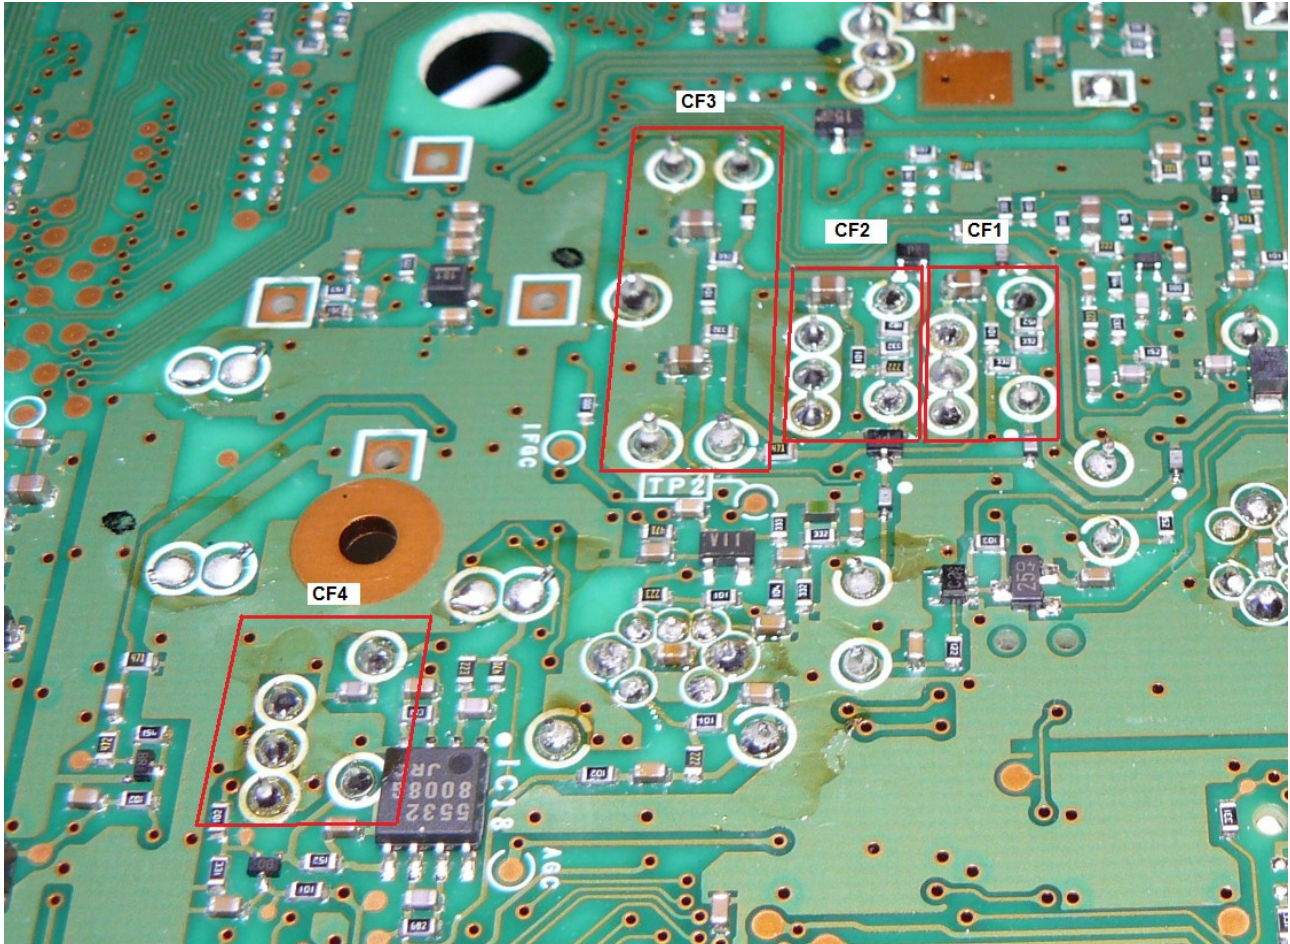
One possible reason for the filter failures are the possibility of too high temperature during soldering with lead-free solder. If too much heat is applied for too long during soldering, the filter may be damaged. During re-soldering I used ordinary “old fashion” solder with 60% tin, 38% lead and 2% copper.

The rear side of the Main TX/RX board do show signs of bad soldering:

The SMD components is of course soldered using a machine, but filters and other large component/parts seems to have been soldered by hand at a later time. There are also some small tin-blobs lying on the board here and there, and on my Radio there was some kind of white powdery substance that was “splashed” out on one corner of the board.

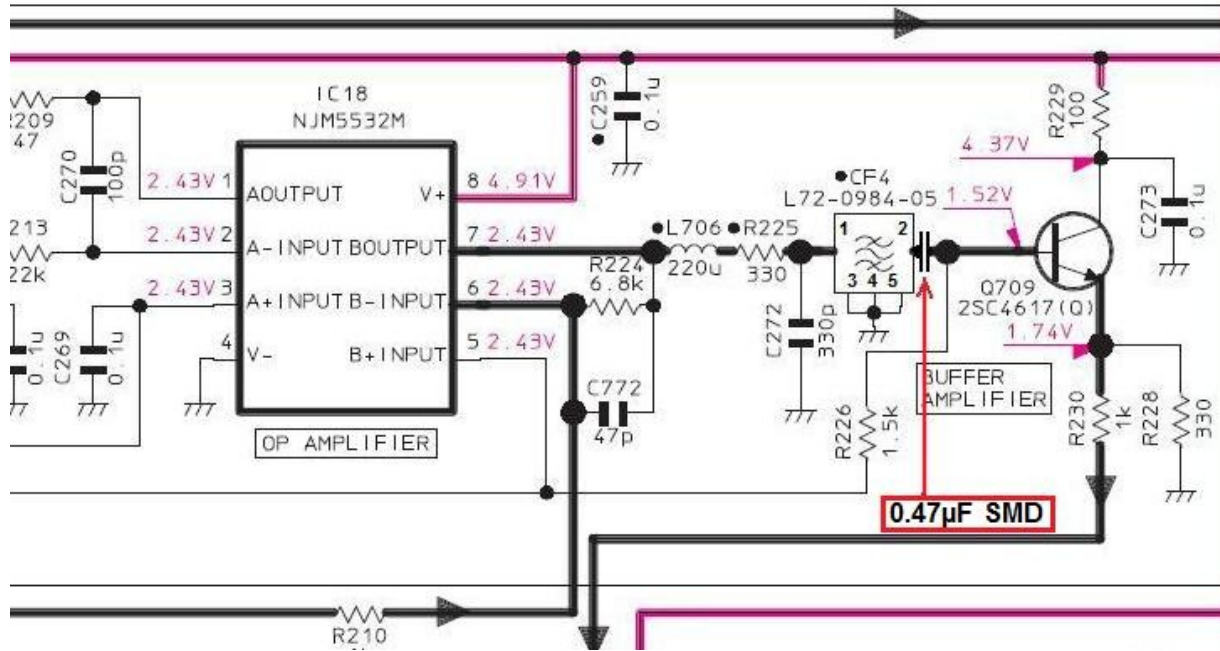
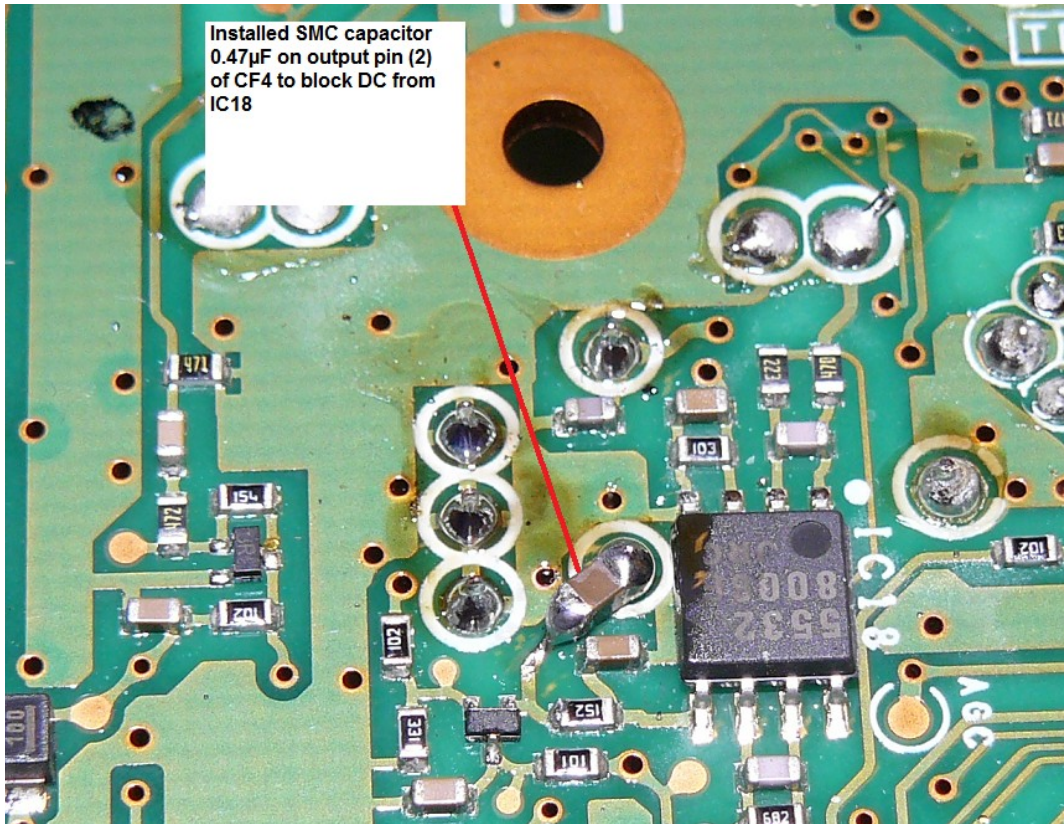
## TS-2000 Main TX-RX unit CF4 ceramic filter circuit

The circuit in the service manual show there is no DC blocking capacitor on the output of the CF4 filter. TOKO recommend a DC decoupling capacitor to be installed for safety reasons. The signal goes thru the resistor R226 (1.5k $\Omega$ ) and directly to pin B+Input on IC. Thus, there is around 1.5V DC on pin 2 on the filter. This must be avoided. So we must install a DC block capacitor on the output of CF4.

Install DC block 0.47uF 0805 X5R capacitor on the output of CF4 to prevent DC from destroying the filter. The X5R has less than 1Ω impedance at 455kHz, so no other impact than DC block will occur in the circuit. You must cut the trace and solder in the SMD capacitor, I found size 0805 to fit nicely. The trace is very small so extreme care must be taken when cutting/soldering.

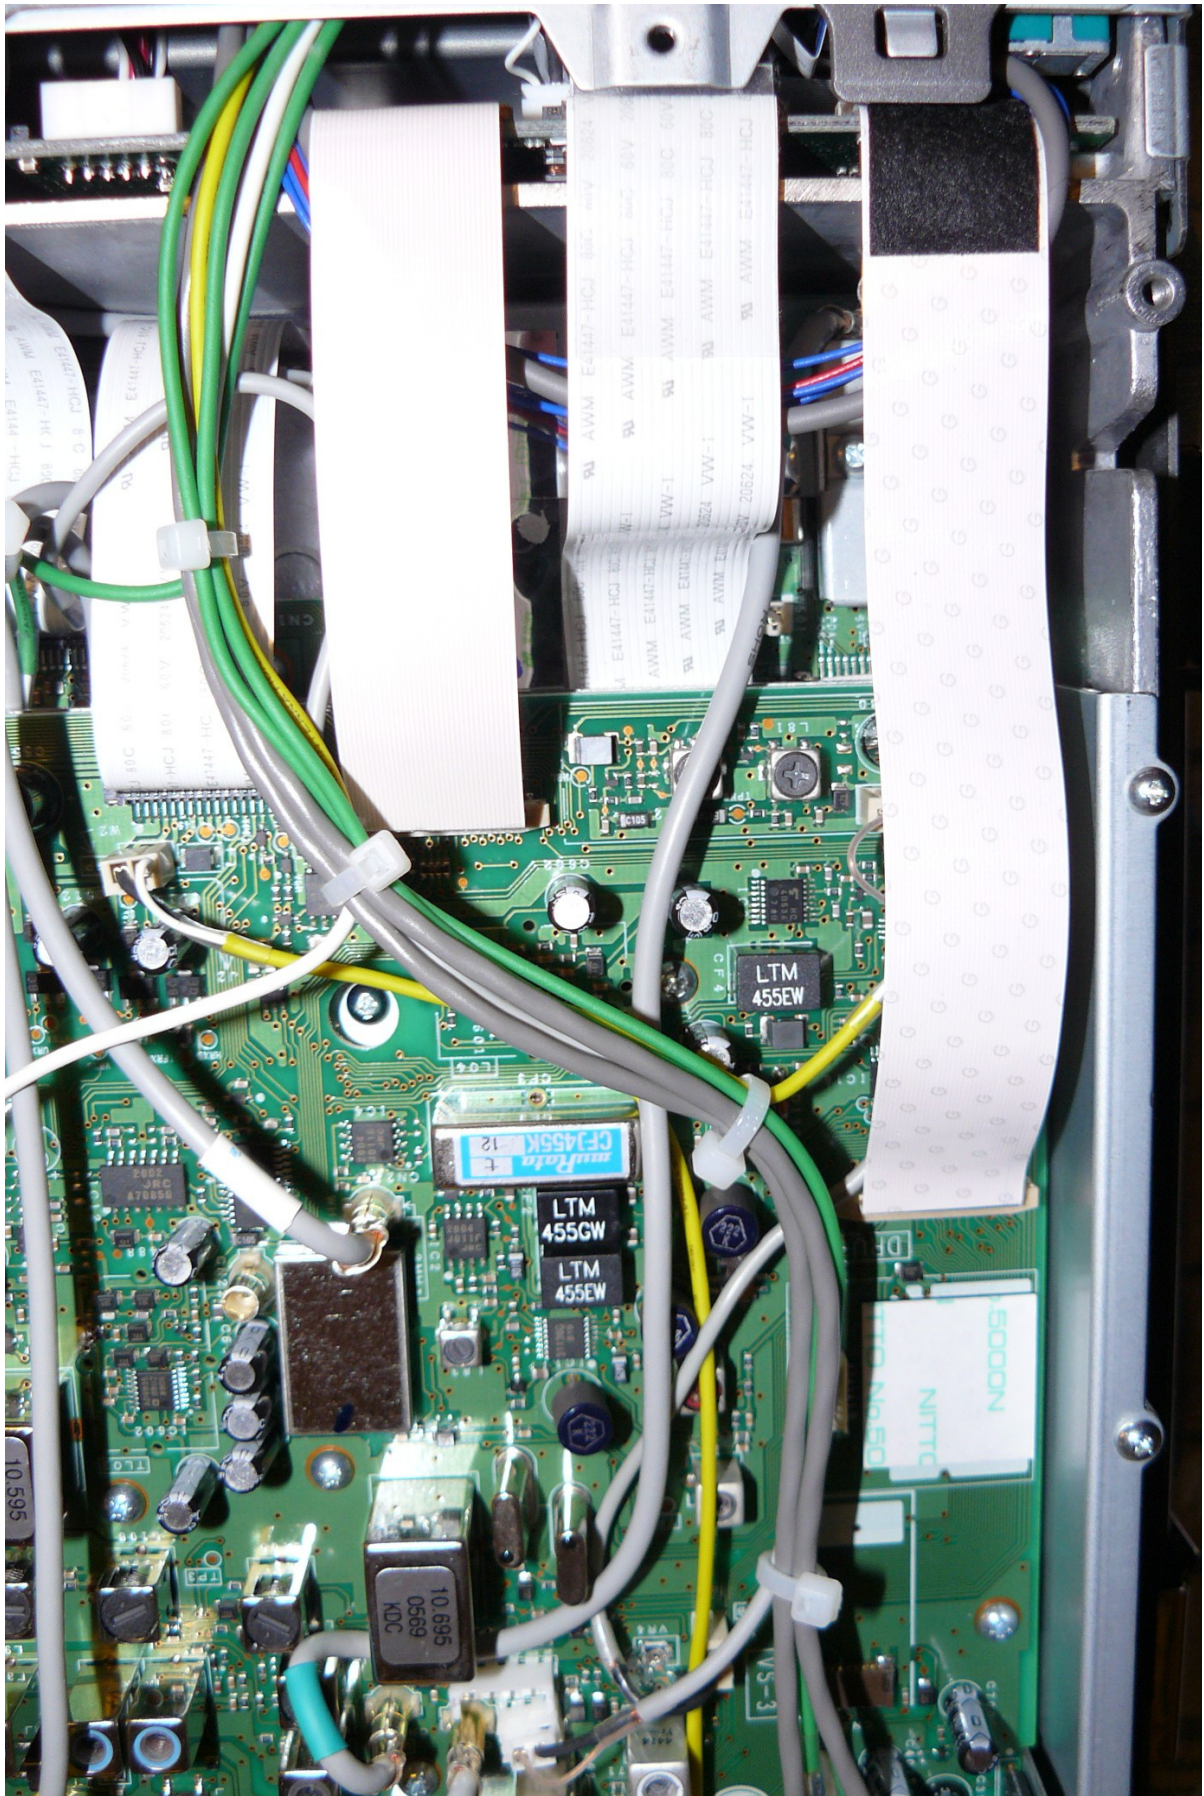
The new filters installed. My TS-2000 now works great, and problem is solved !
